CALIFORNIA DIVISION OF MINES AND GEOLOGY

FAULT EVALUATION REPORT FER-111

SUPPLEMENT NO. 1

Maacama fault (Ukiah and Willits segments).

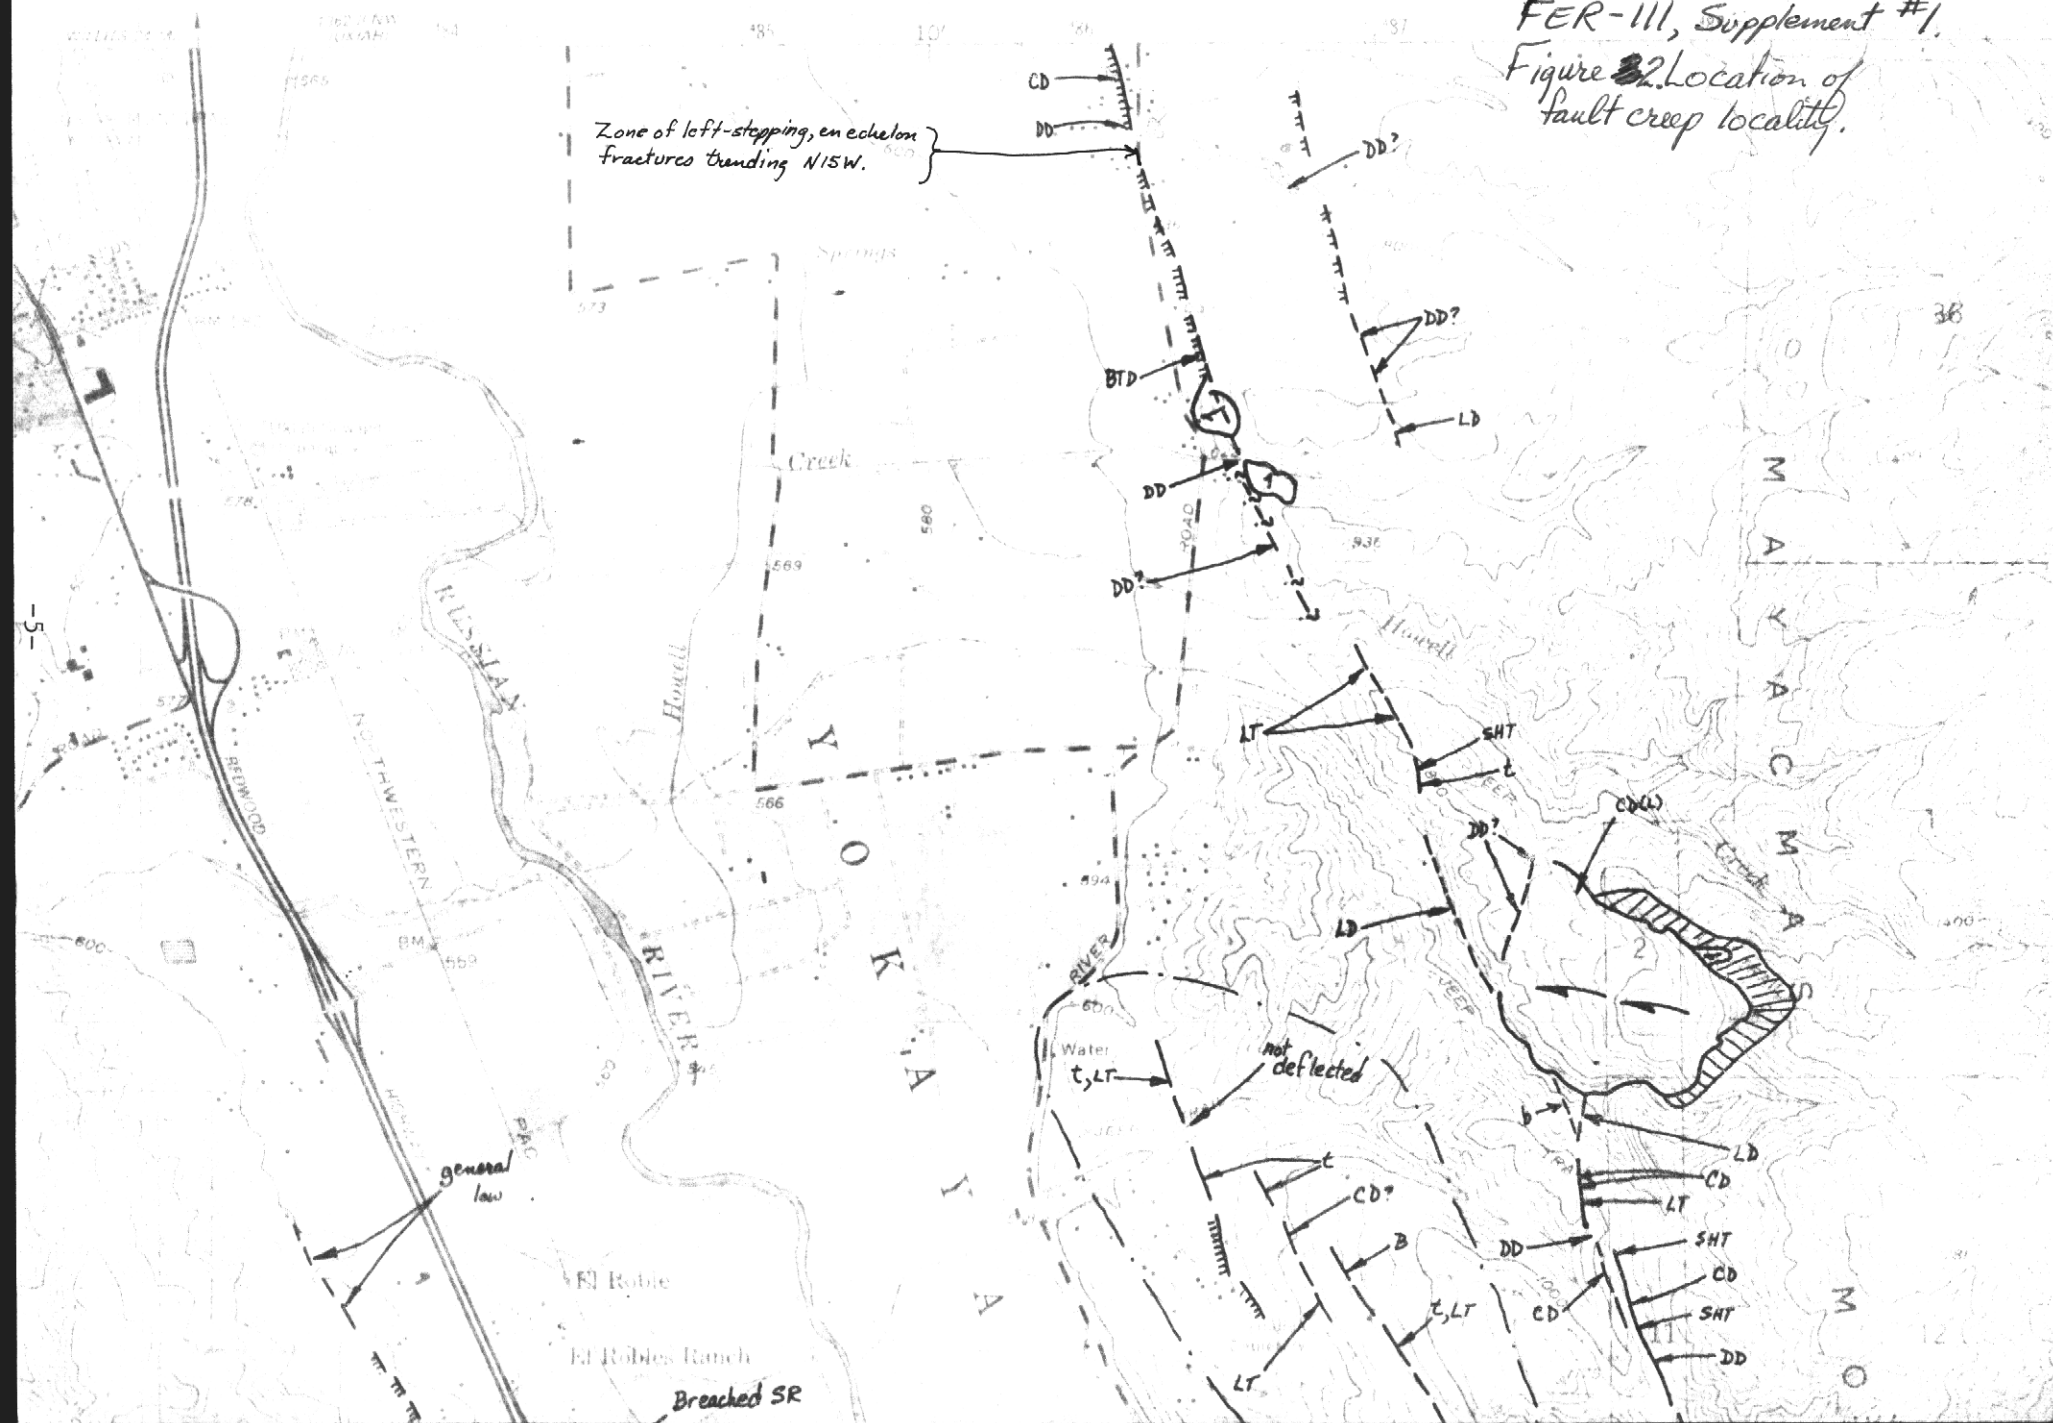
Figure 32. Location of
fault creep locality.

One additional fault creep locality has been found along River Road (Elledge Peak quadrangle, Fig. 2). This is a narrow zone of left-stepping, en echelon cracks in pavement on trend with the fault features previously delineated.

1. Add the fault creep locality on River Road (Elledge Peak quad);
2. Add the fault exposed in the banks of the Russian River (Ukiah quad).
3. Use Upp (1981) since it contains more complete information than Upp (1980).

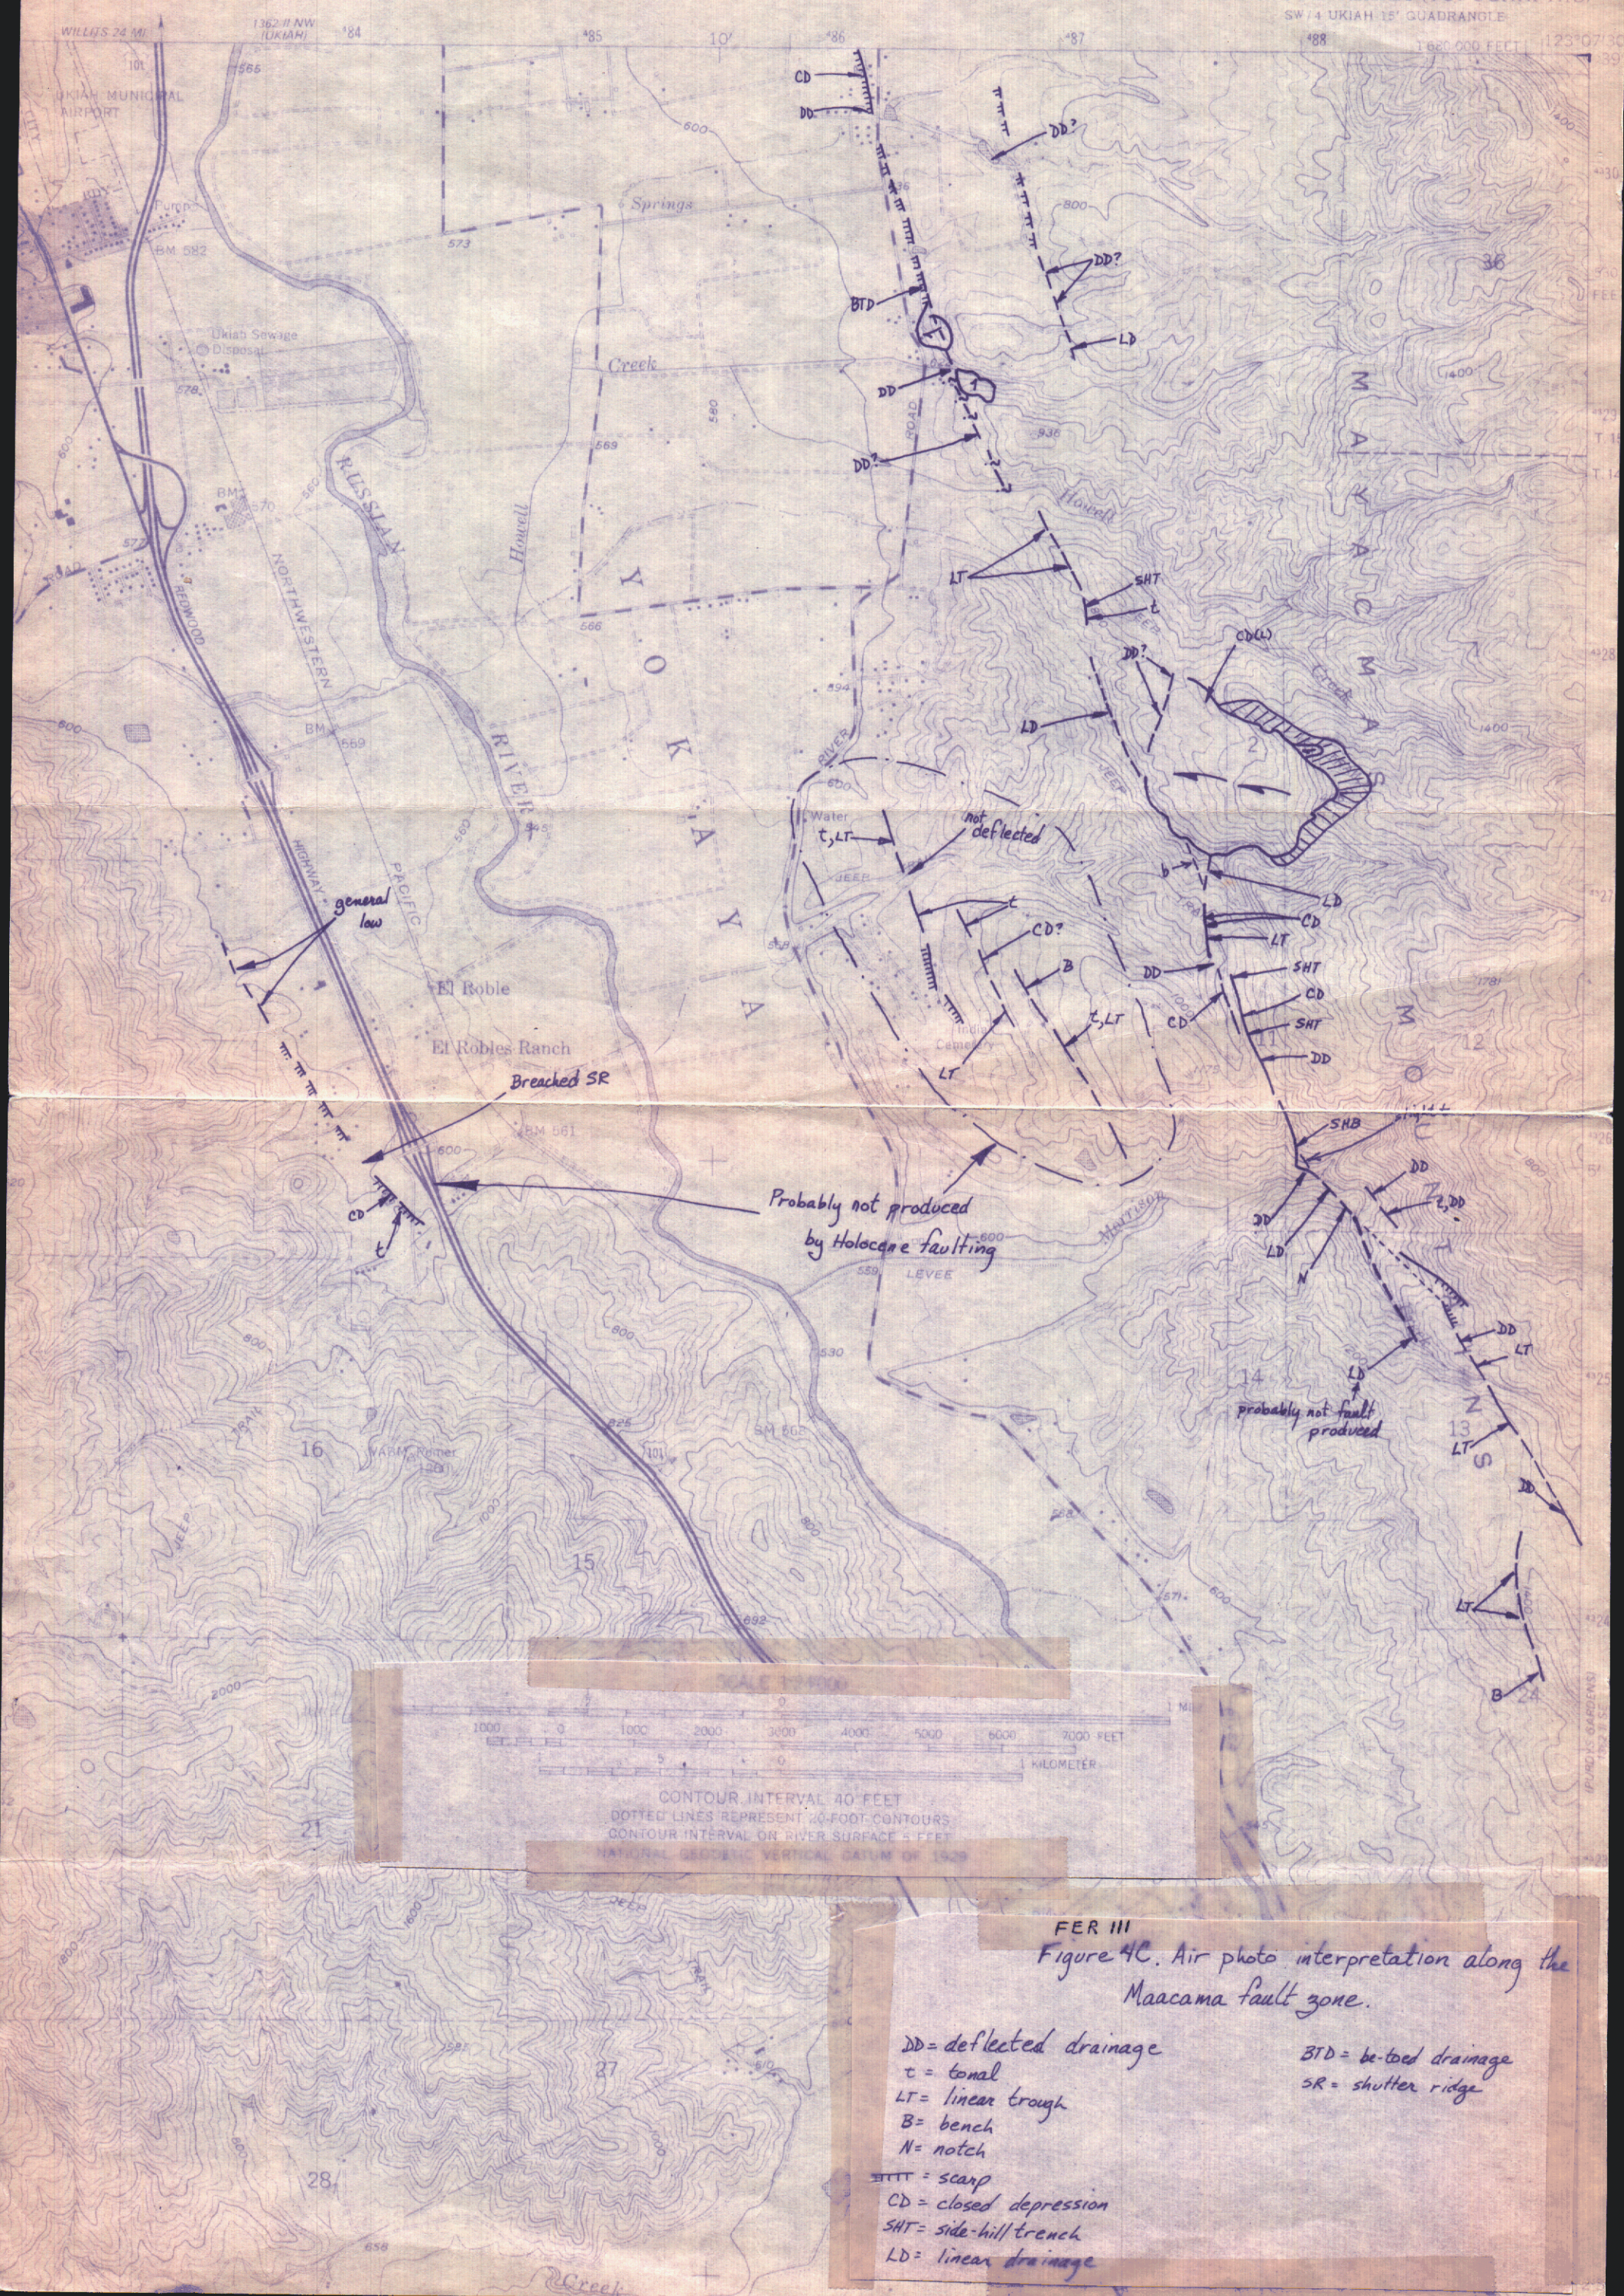
FER III
 Figure 4C. Air photo interpretation along the
 Maacama fault zone.

USDA (1952; 1963) aerial photographs were interpreted in order to determine whether any of the additional faults shown by Upp (1981) warranted zoning. In addition, the newly received aerial photos covering additional areas within the three quadrangles studied were reviewed. No additional features suggestive of Holocene strike-slip faulting were noted in the study areas. All reported fault features located outside the recommended SSZ appear to have resulted from other than Holocene fault movement.
